## Technical Note

### THERMOCOUPLE GROUNDING ISSUE

**Scope:** Force 10 Ranges built between the years of 2001 and 2003

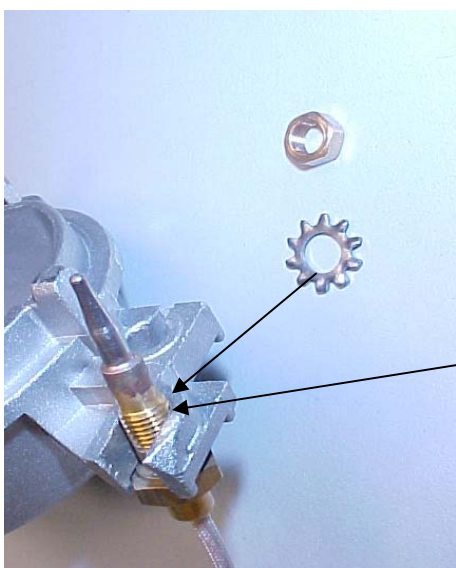
In some cases the connection point is not solid enough (due to corrosion or grease build up) to transmit current.

**This is the ground connection point where the thermocouple completes the circuit.**

This can be fixed by cleaning up the connection. In addition a stainless steel star washer can be added to the connection point which helps bite into the burner body and the thermocouple to create a better connection.

**The addition of a Stainless Steel # 10 star tooth washer can help make a better connection.**
